LARGE CULVERT STUDIES IN MONTANA

Prepared for
Montana Highway Commission
Planning Survey Section
in cooperation with
U . S . Department of Transportation
Bureau of Public Roads

Alfred C . Scheer

1968

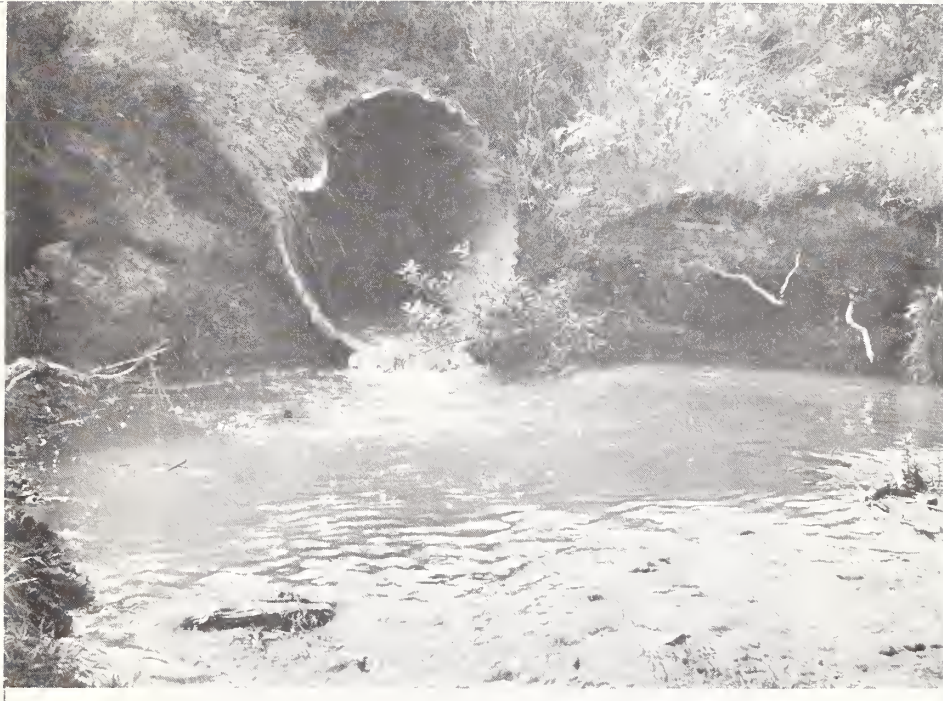
FIGURE 1. OUTLET SCOUR HOLE AT PROJECT CULVERT NO. 5

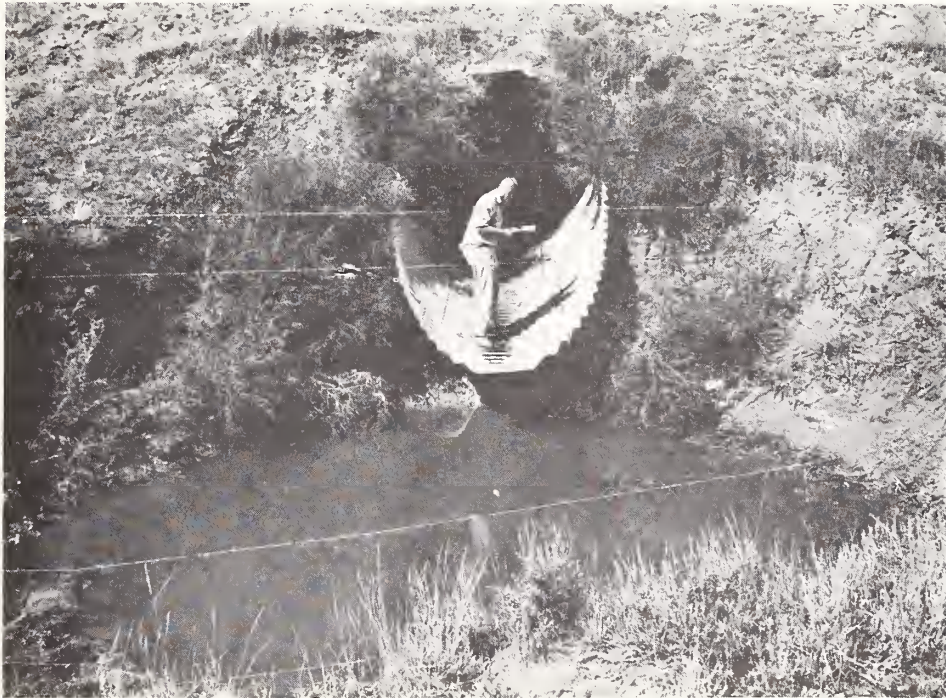
FIGURE 2. OUTLET SCOUR HOLE AT PROJECT CULVERT NO. 8

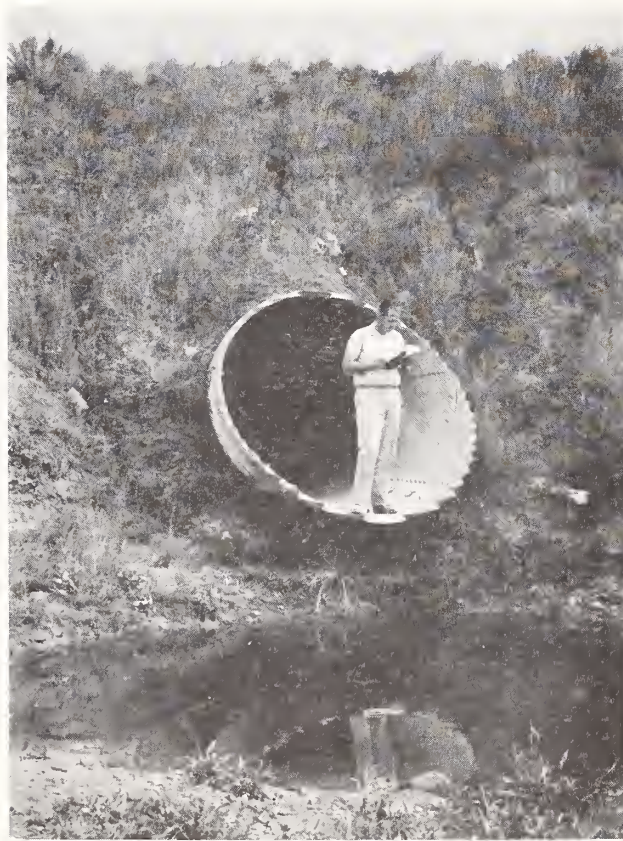
FIGURE 3. OUTLET SCOUR HOLE AT PROJECT CULVERT NO. 45

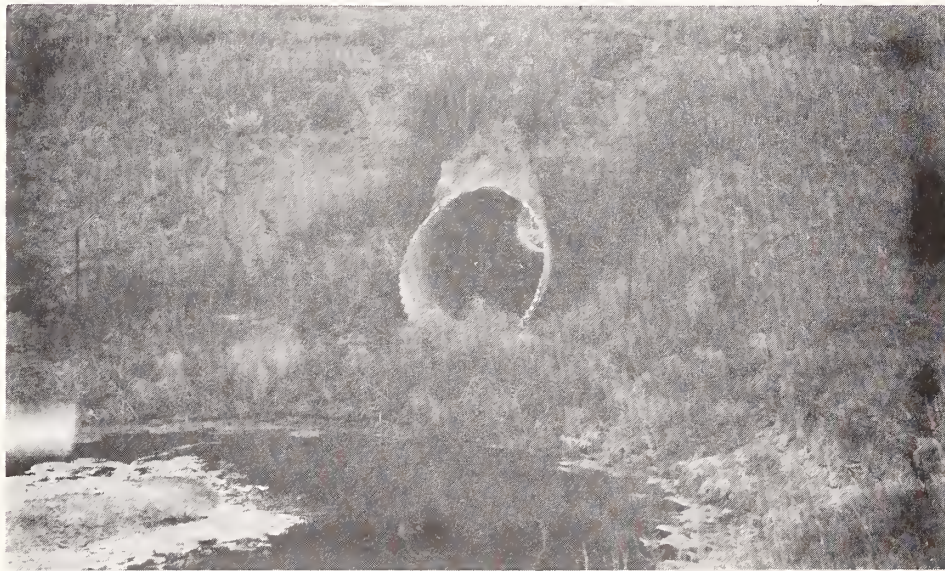
FIGURE 4. OUTLET SCOUR HOLE AT PROJECT CULVERT NO. 52

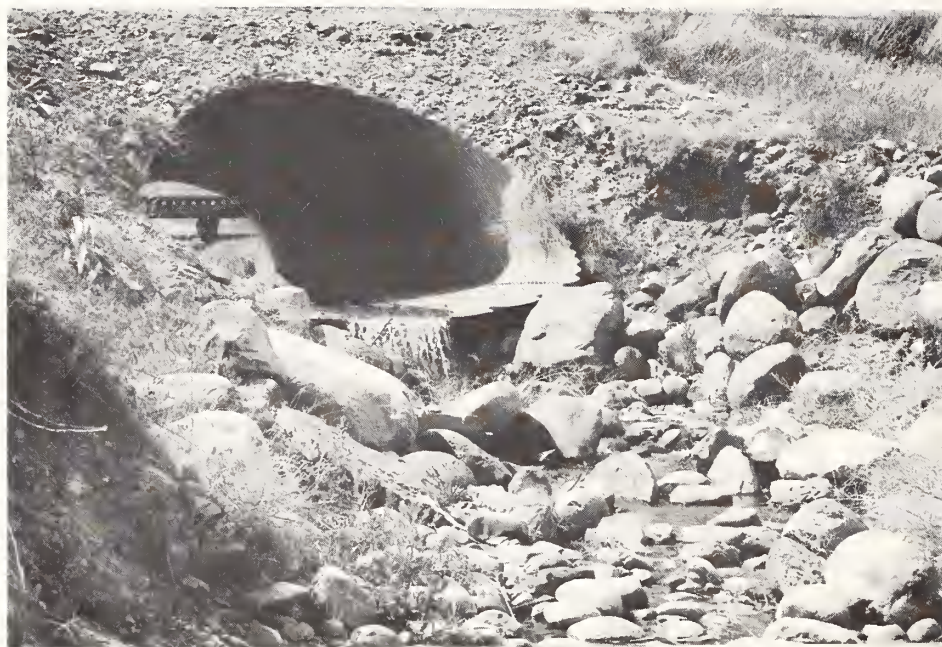
FIGURE 6. OUTLET OF CULVERT NO. 1
Most of the large rocks were placed in the channel in attempts to provide scour protection.

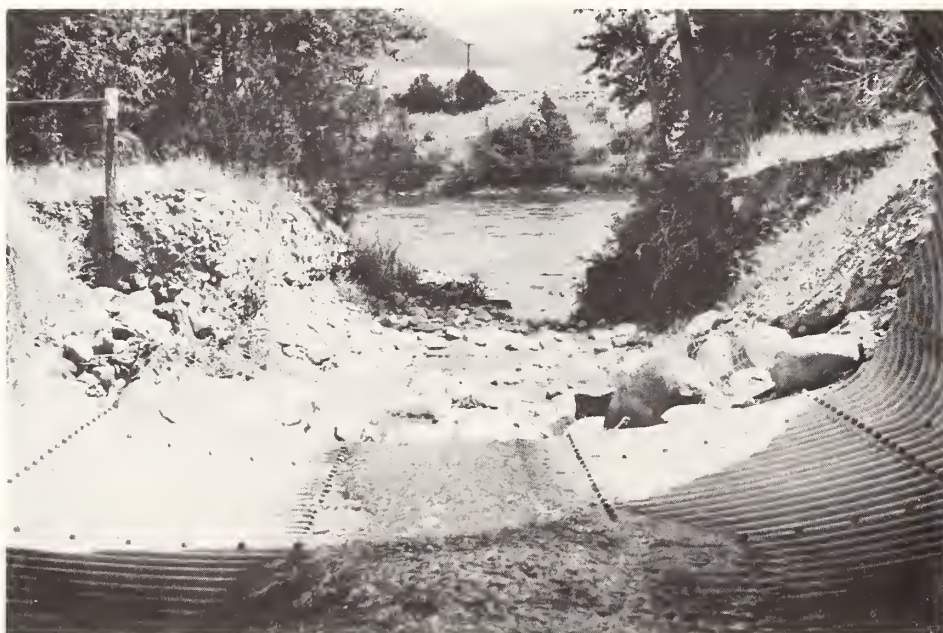
FIGURE 7. DEGRADED OUTLET CHANNEL OF CULVERT
NO. 1, TERMINATING IN THE YELLOWSTONE RIVER
Notice undermining of fence post on left and trees on right.

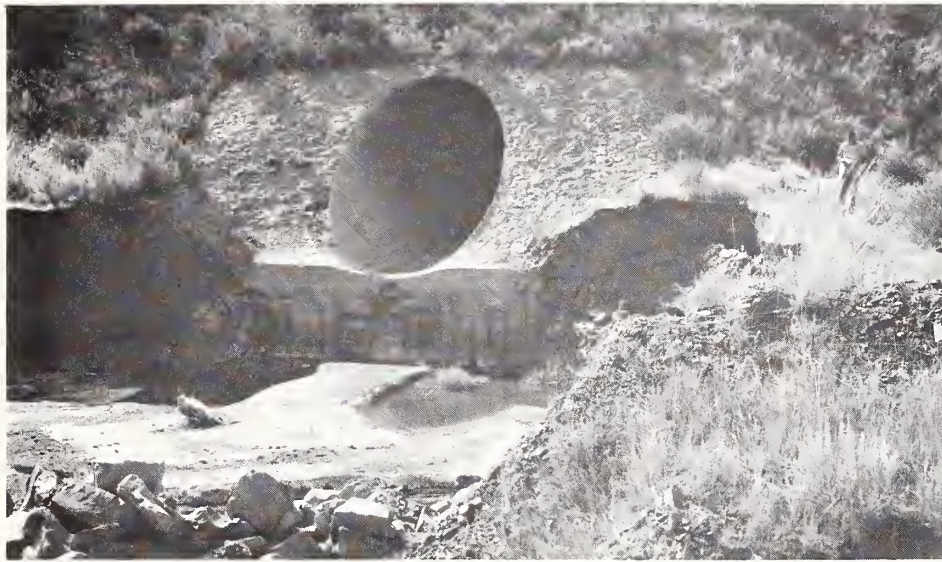
FIGURE 8. OUTLET OF CULVERT NO. 25
Note partial failure of grouted riprap outlet protection.

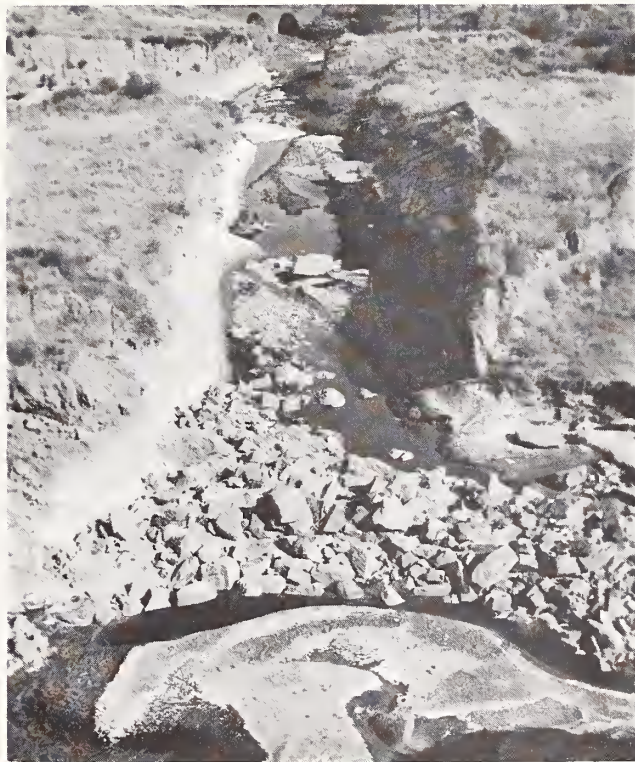
FIGURE 9. DEGRADED DOWNSTREAM CHANNEL OF CULVERT NO. 25
Note riprap dam in outlet channel.

The outlet scour problem at project culvert No. 25, shown earlier in Figures 8 and 9, is another particularly interesting case. This culvert has had water backed up six feet above its crown at the inlet and has flowed

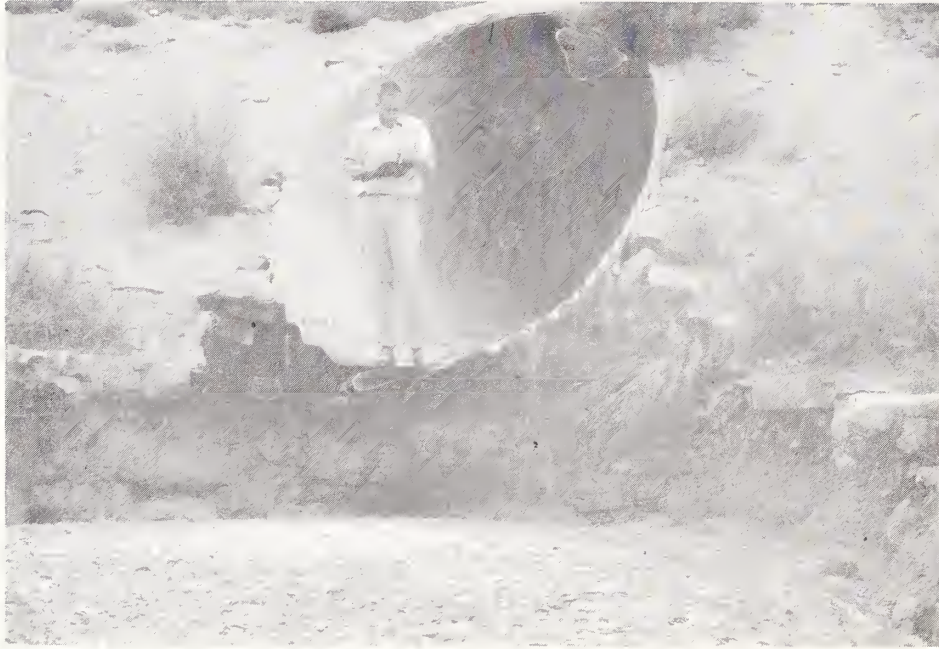
FIGURE 10. OUTLET OF CULVERT NO. 40
Note partial failure of grouted riprap.

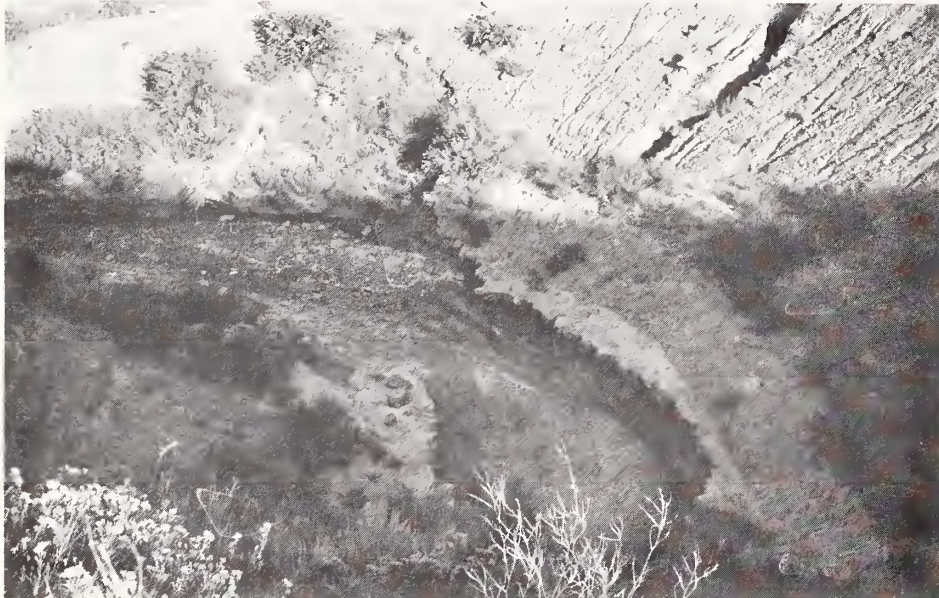
FIGURE 11. DEGRADED OUTLET CHANNEL OF CULVERT NO. 40
Remnants of a grouted riprap outlet apron are visible in the picture.

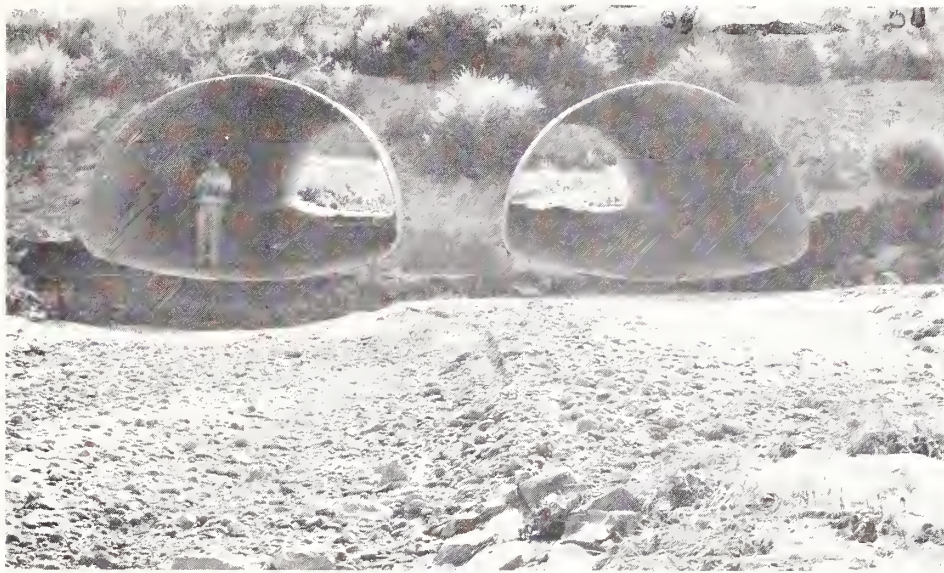
FIGURE 12. OUTLET OF CULVERT NO. 41
A grouted riprap outlet apron has been completely washed away.

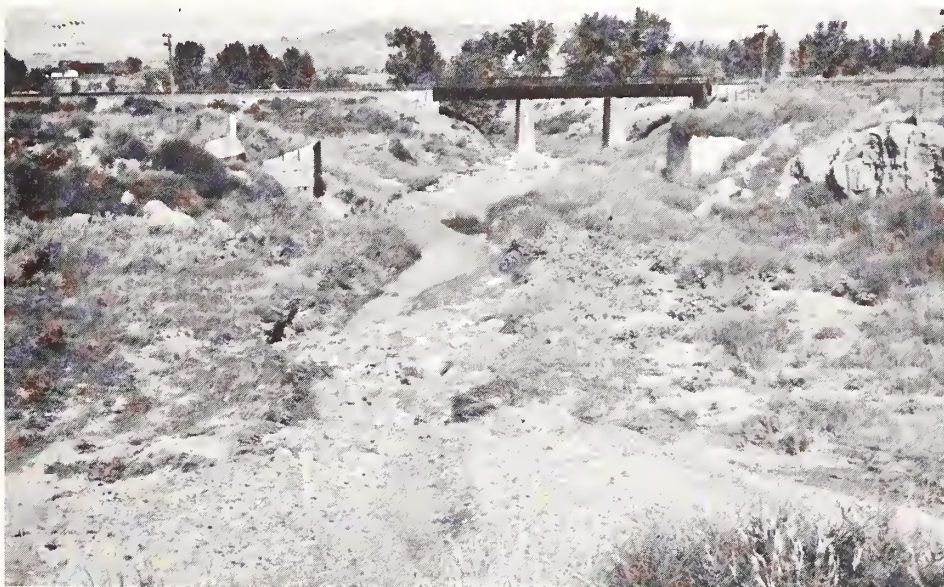
FIGURE 13. OUTLET CHANNEL OF CULVERT NO. 41
The channel degradation is not severe in this case.

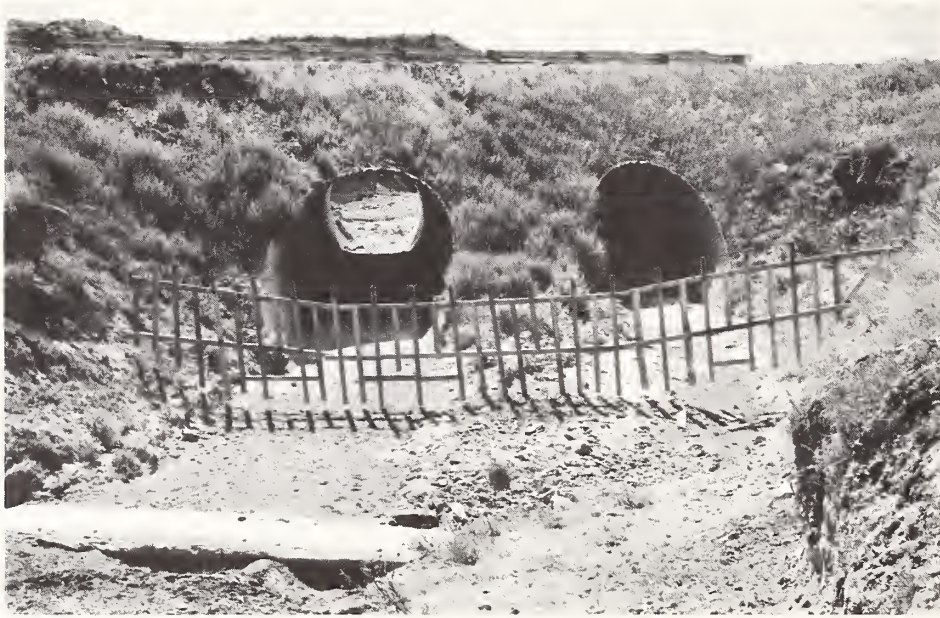
FIGURE 15. OUTLET OF CULVERT NO. 26
A natural sandstone "ditch check" is visible in foreground.

may be attributed to a series of erosion-resistant parallel sandstone dikes which cut across the outlet channel and form a series of near-perfect natural ditch checks .

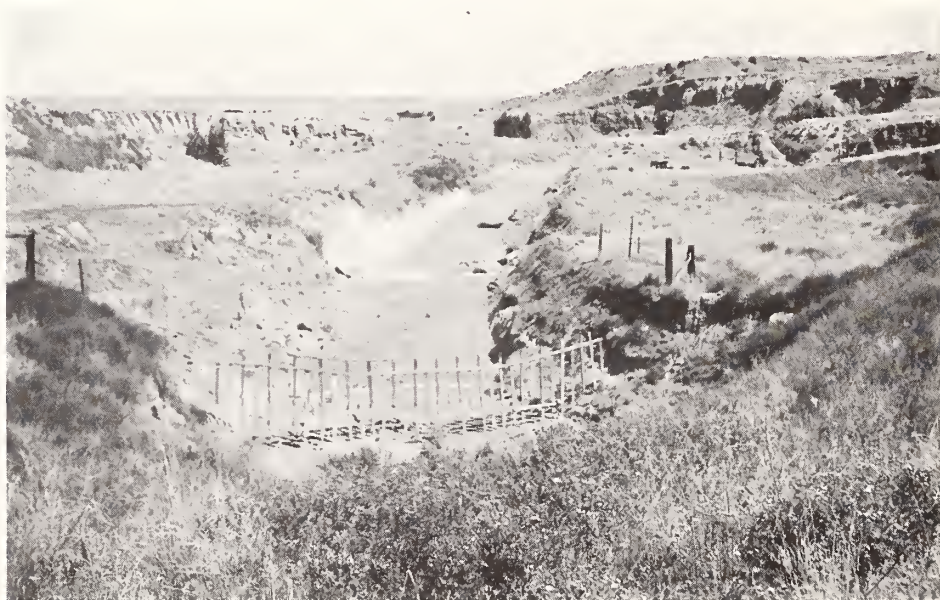
FIGURE 16. OUTLET CHANNEL OF CULVERT NO. 26
A series of sandstone dikes form natural ditch checks which effectively prevent degradation of the straightened channel.

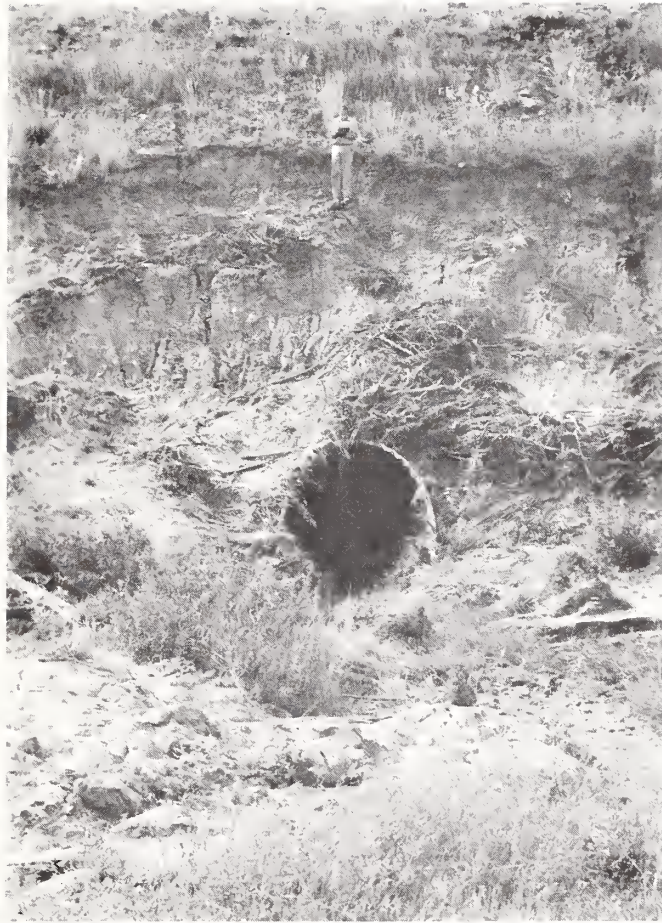
Figure 18 shows the unprotected inlet of project culvert No. 48 shortly after a 1963 flash flood that piled up water to a depth of 15 feet above the inlet crown. Damage to the steep sandy silt embankment at the inlet appears

FIGURE 18. INLET OF CULVERT NO. 48 AFTER A FLASH FLOOD IN 1963

to be more a matter of sluffing than scouring. This 84 inch diameter culvert is constructed of 10-gage plates.

A shallow cutoff wall and/or moderate riprap protection appears sufficient to prevent serious scour damage at most large culvert entrances.

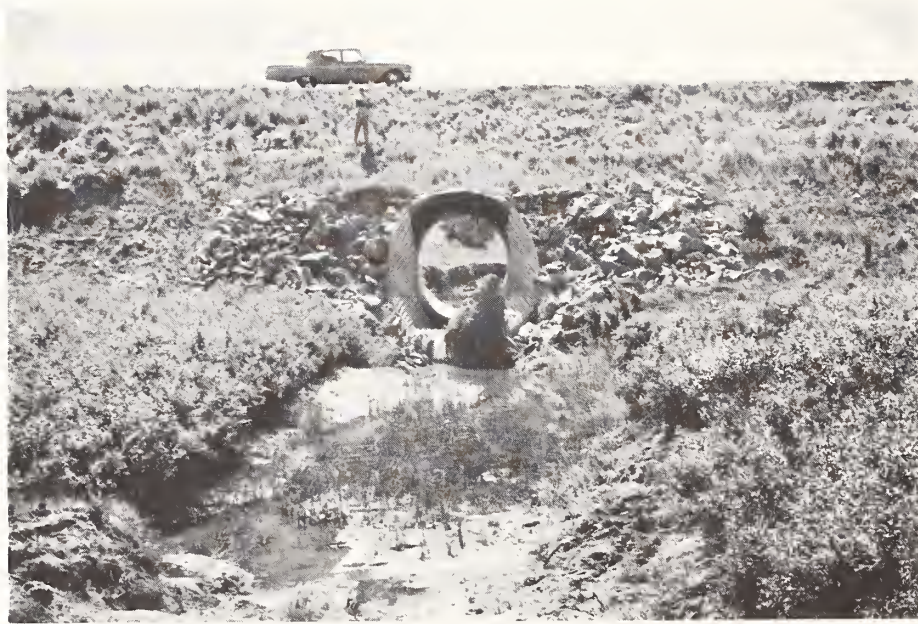
FIGURE 19. COLLAPSED INLET OF THE MUSKRAT CREEK CULVERT

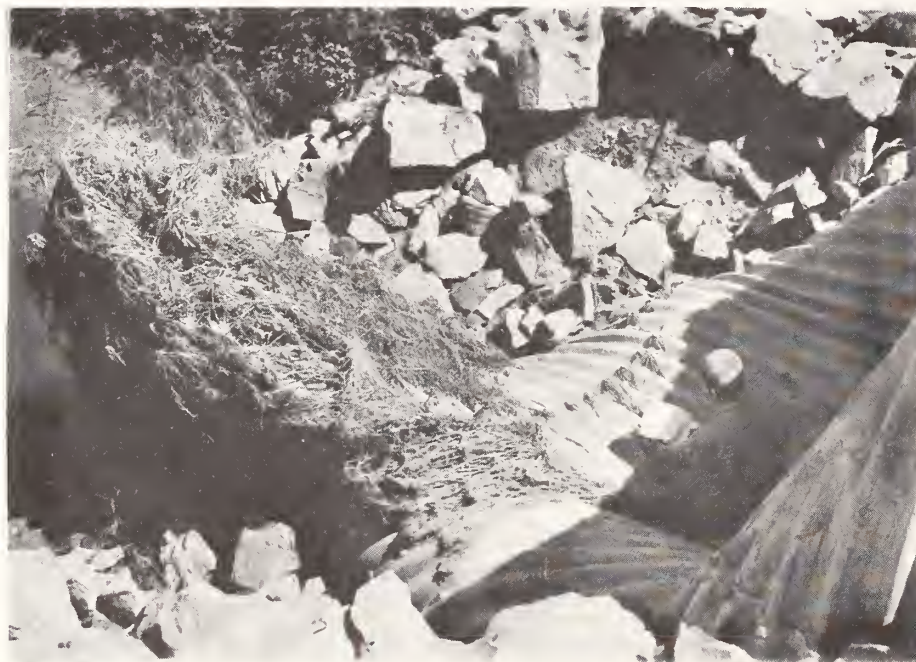
FIGURE 20. THE COLLAPSED INLET OF THE MUSKRAT CREEK CULVERT AS VIEWED FROM ABOVE AND OFF TO ONE SIDE.

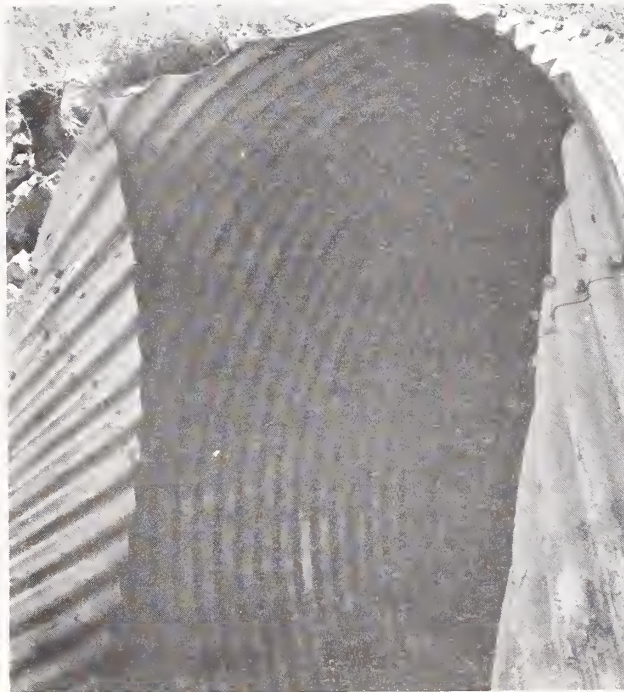
FIGURE 21. CLOSE-UP VIEW OF THE TOP PART OF THE COLLAPSED INLET OF THE MUSKRAT CREEK CULVERT.

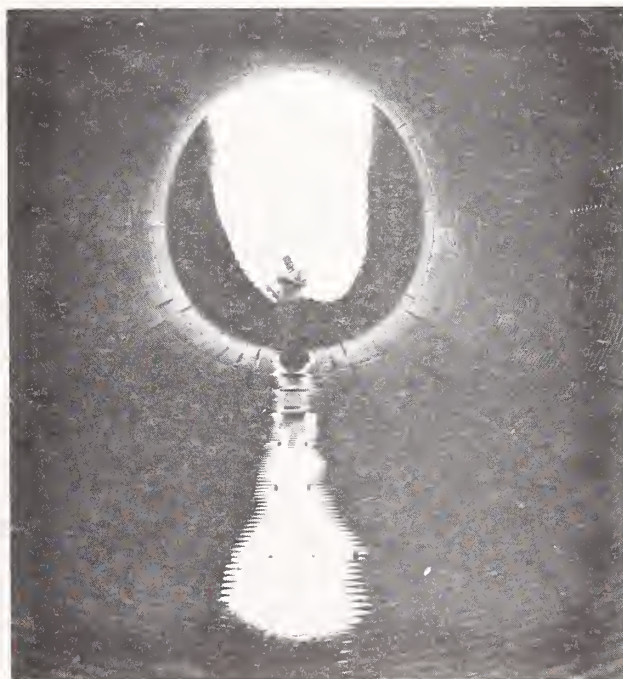
FIGURE 22. THE COLLAPSED INLET OF THE MUSKRAT CREEK CULVERT, AS VIEWED FROM INSIDE THE CULVERT.

Notice the greatly reduced inlet waterway area.

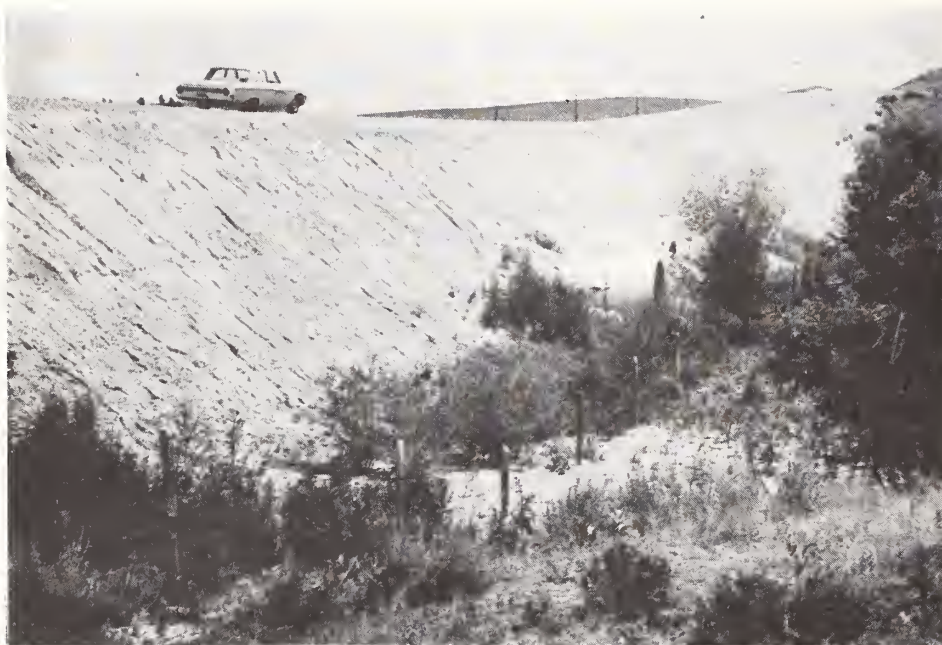
FIGURE 25. INLET OF PROJECT CULVERT NO. 4

pictures were taken, so it is assumed that it occurred in the spring of 1963. In Figure 25 the high water line is visible on the embankment slope, about three feet above the top of culvert No. 4. There was a similar high water mark just barely above the top of the inlet of culvert No. 3.

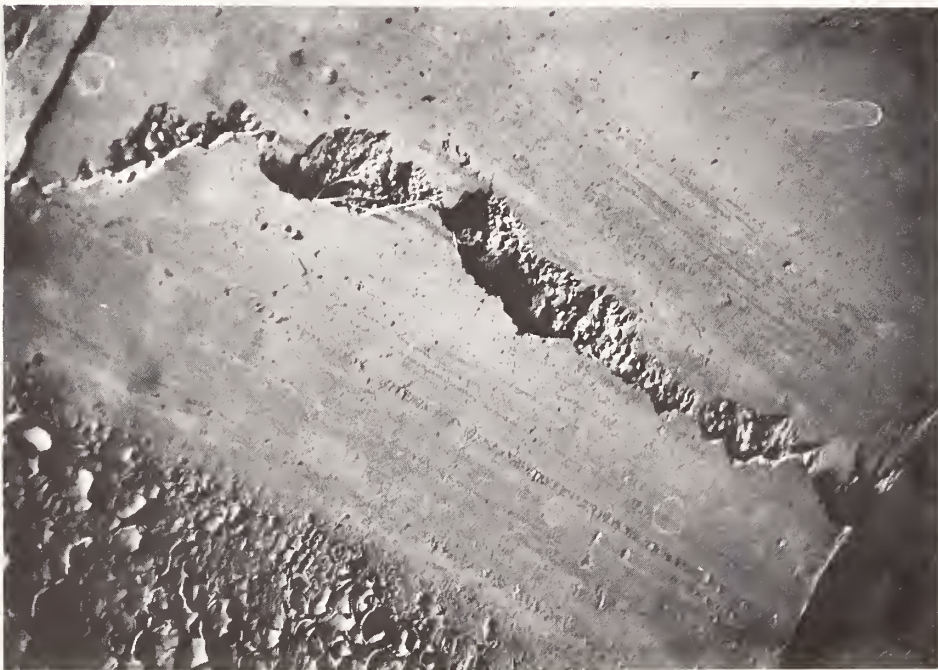
FIGURE 28. CRACK ON FLOOR OF CULVERT NO. 53

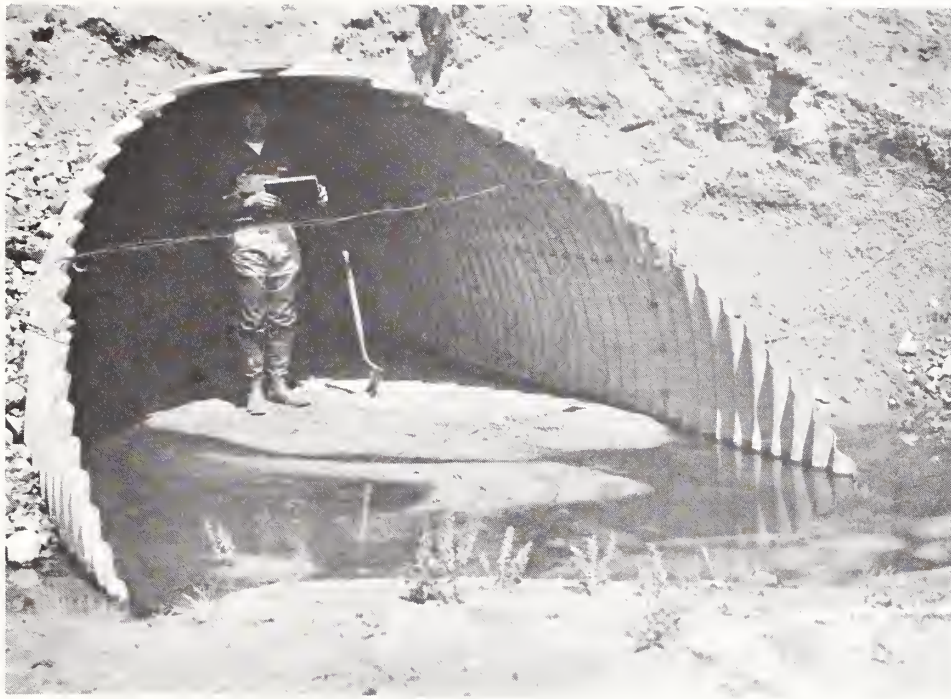
FIGURE 29. FIVE FEET OF SEDIMENT IN CULVERT NO. 7

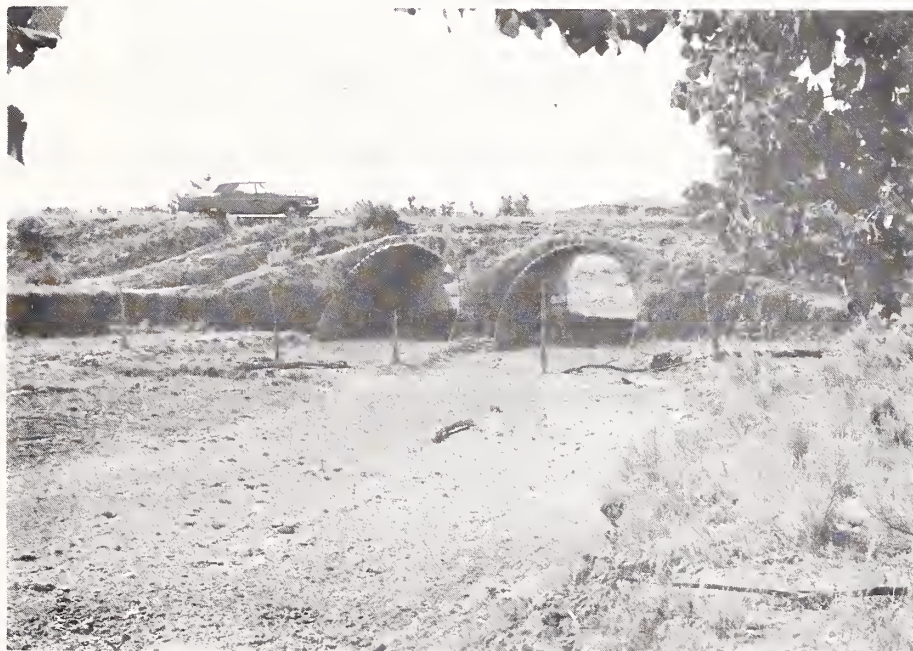
FIGURE 30. CULVERT NO. 28 WITH A FIVE FOOT DEPTH OF SEDIMENT
This installation blends in gracefully with the terrain.

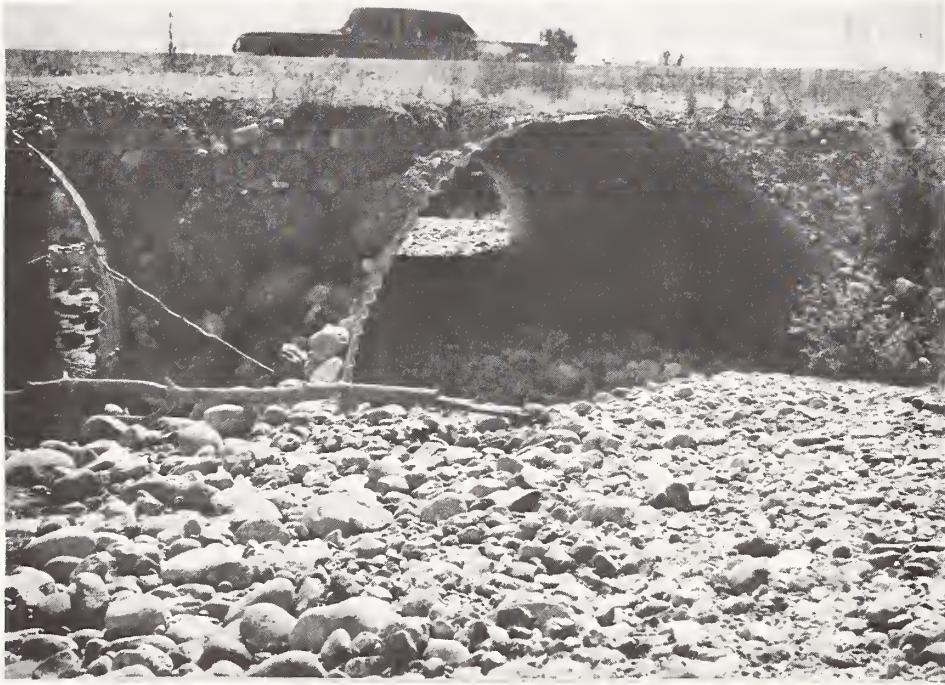
Figures 31 and 32 show project culvert No. 12, a twin pipe-arch installation, as it appeared in the summer of 1963, with a two-foot depth of boulder-size sediment in one barrel and about half that amount in the other. The reason for the sediment deposit in this case is apparent in Figure 32. Large rocks were dumped in the channel, about 25 yards downstream from

FIGURE 31. SEDIMENT IN CULVERT NO. 12
The right barrel of this pipe-arch installation contains a 2-foot depth of sediment.

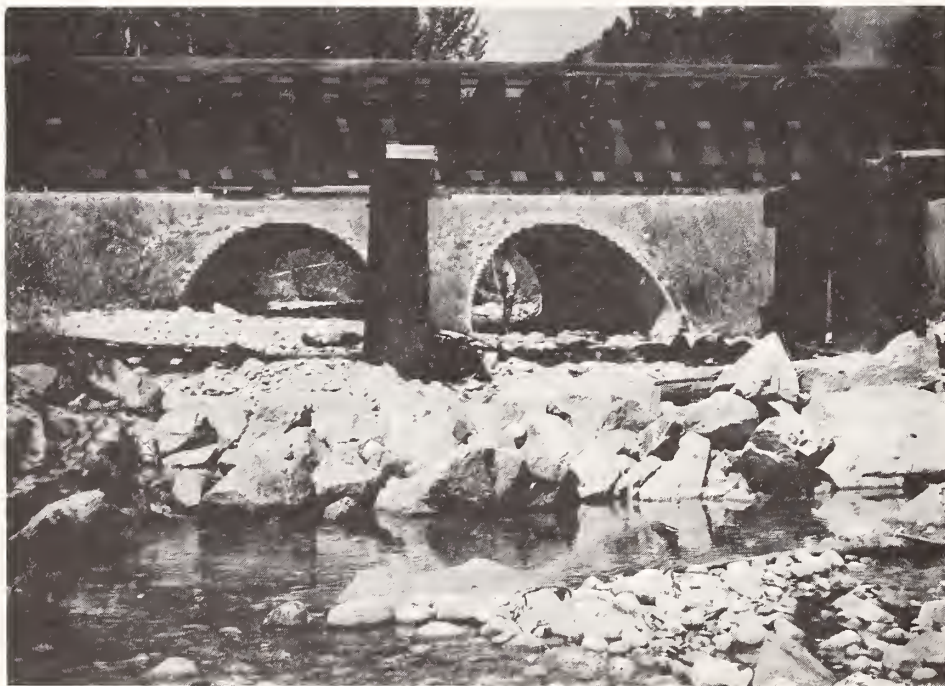
FIGURE 32. A RIPRAP DAM DOWNSTREAM FROM CULVERT NO. 12

the culvert, to protect a railroad trestle against scour. These rocks formed a dam, about two feet high, which resulted in a corresponding rise of the streambed upstream from the dam. This is a highly predictable case of channel aggradation.

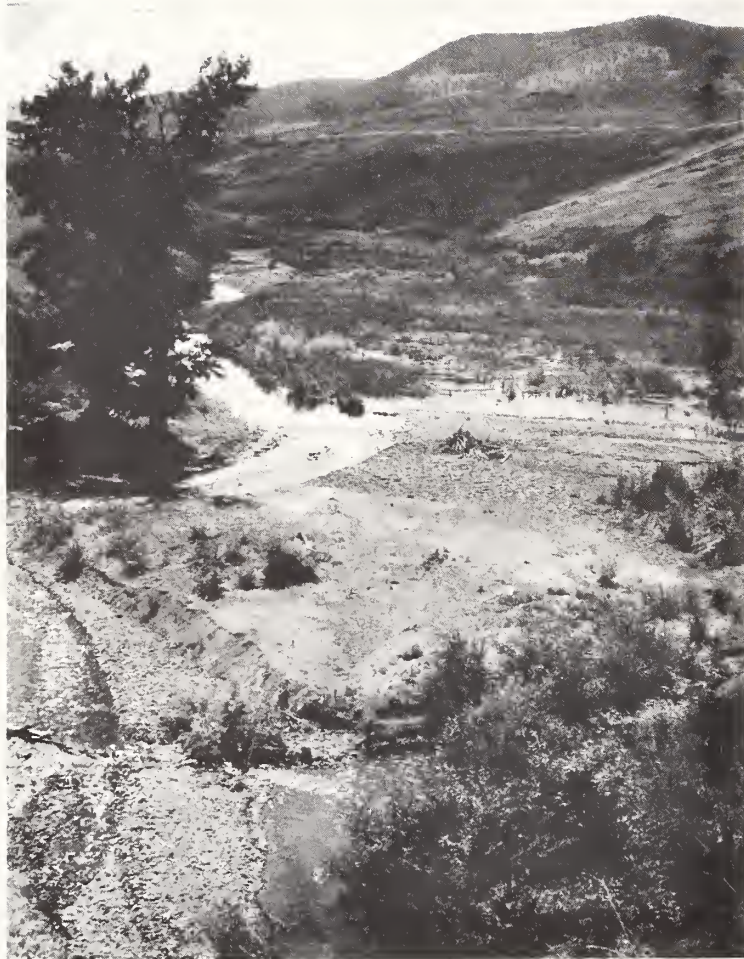
FIGURE 33. THE CHANNEL UPSTREAM FROM CULVERT NO. 51,
AFTER THE 1964 FLOOD

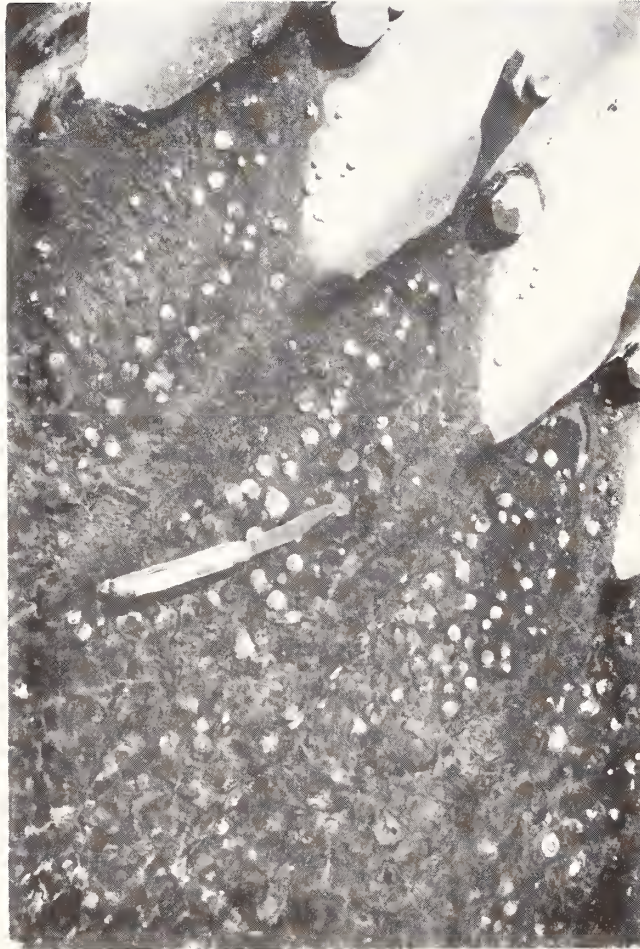
The nodules are firmly attached to the plates and a sharp blow is required to break one off. When this is done, the exposed metal is clean and bright, but there is usually a small but deep pit at the center.

FIGURE 34. CORROSION NODULES ON THE FLOOR
OF PROJECT CULVERT NO. 10

The nodules also exist on the under-side of the floor--at least at the outlet end of culvert No. 10 where they could be felt with the fingers on the bottom side of the floor plates .

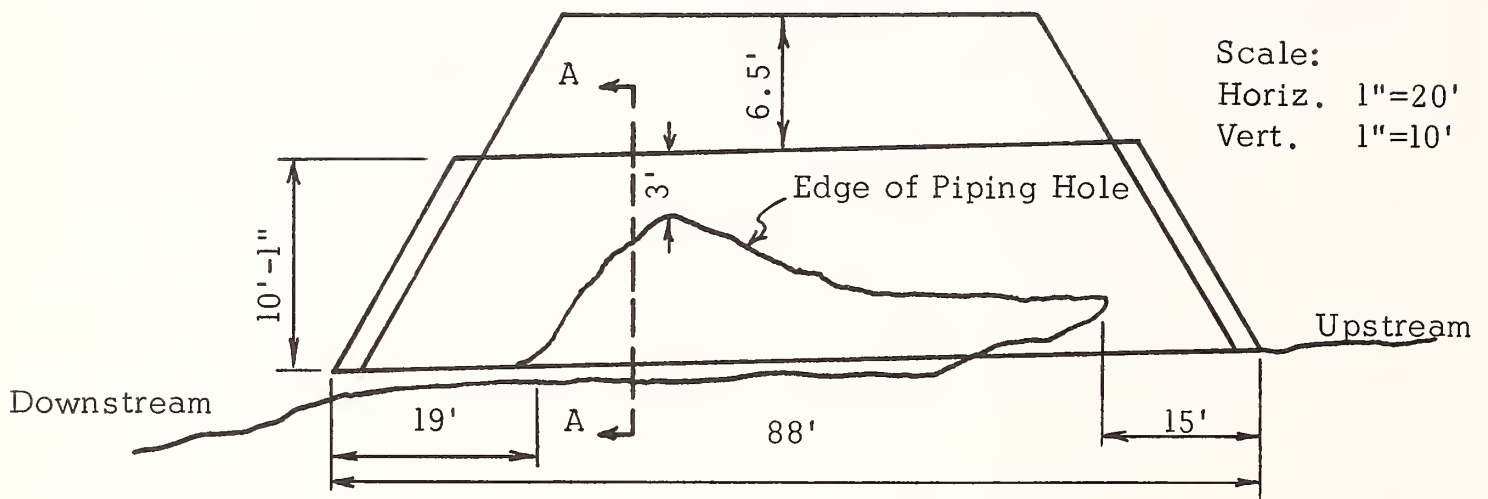
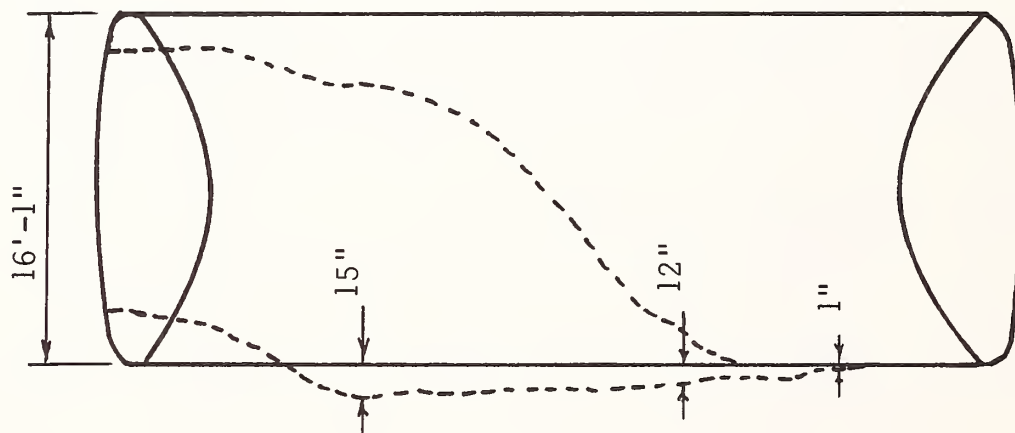
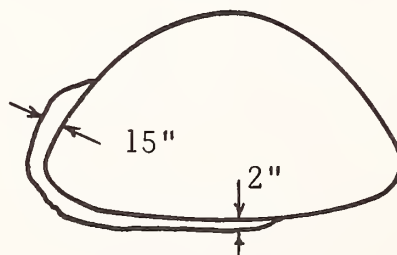
The approximate boundaries of the piping channel, as traced out by the 1964 punch-hole survey, are shown in Figure 35.

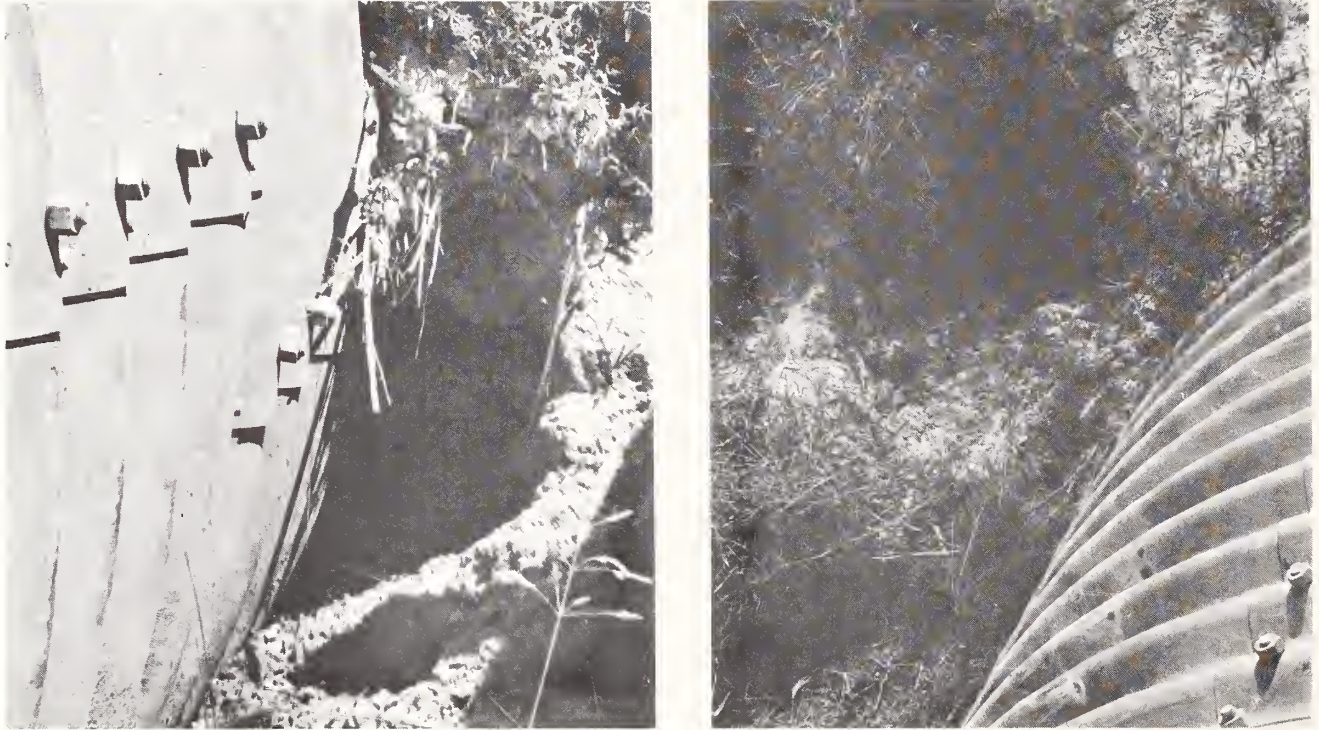
FIGURE 36. INLET AND OUTLET OF PIPING HOLE AT THE CARDWELL CULVERT

The picture on the left shows the inlet piping hole which extended back as far as could be seen with a flashlight. The picture on the right shows the outlet piping hole which was large enough for a man to crawl into.

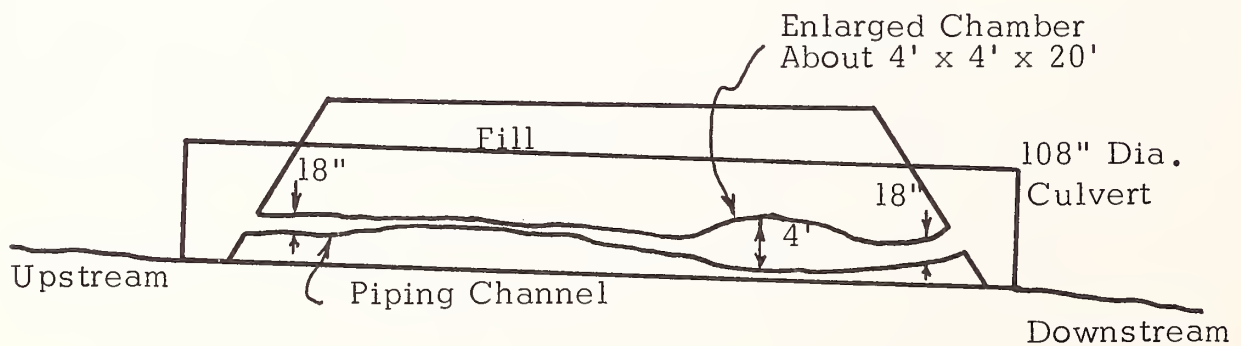
FIGURE 37. SKETCH OF CARDWELL PIPING CHANNEL

Shown is a profile section of the piping channel along the right side of this culvert.

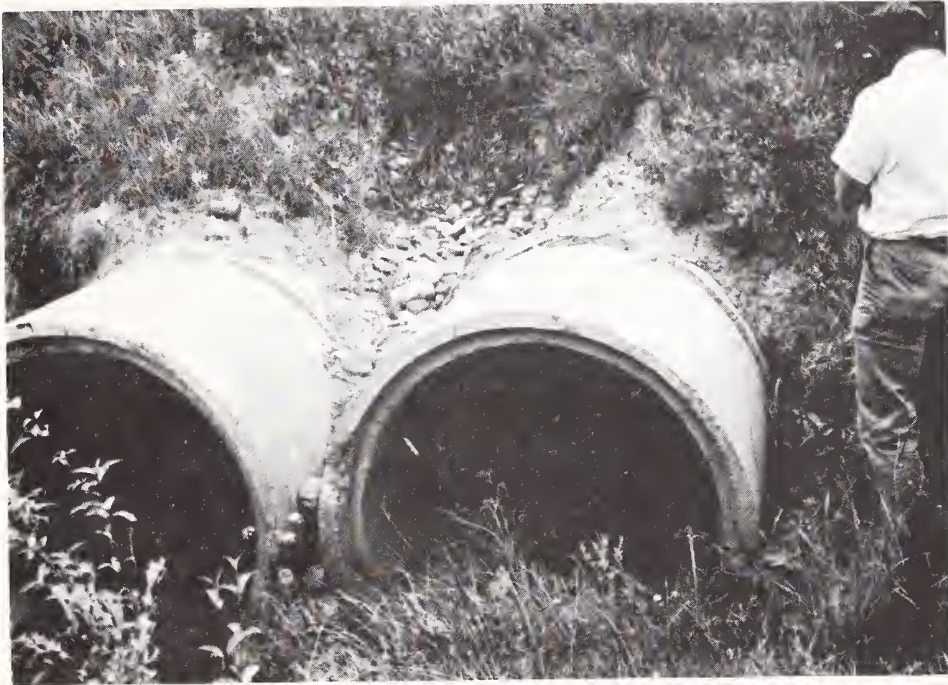
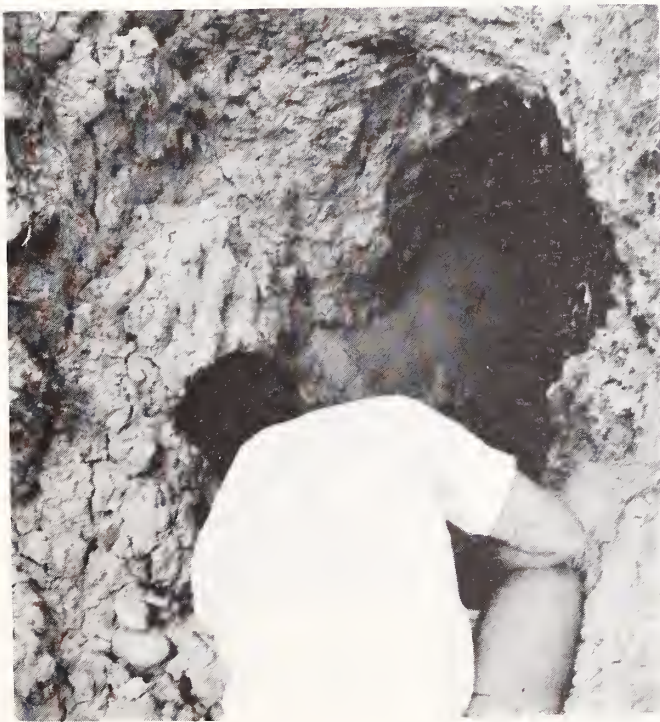
The top picture of Figure 38 shows the inlet end of the culvert, where piping holes were also present on each side. They do not show up well in the picture, however. Between the pipes, at the inlet, there was a

FIGURE 38. INLET AND OUTLET
OF THE O'KEEFE CULVERT, 1963

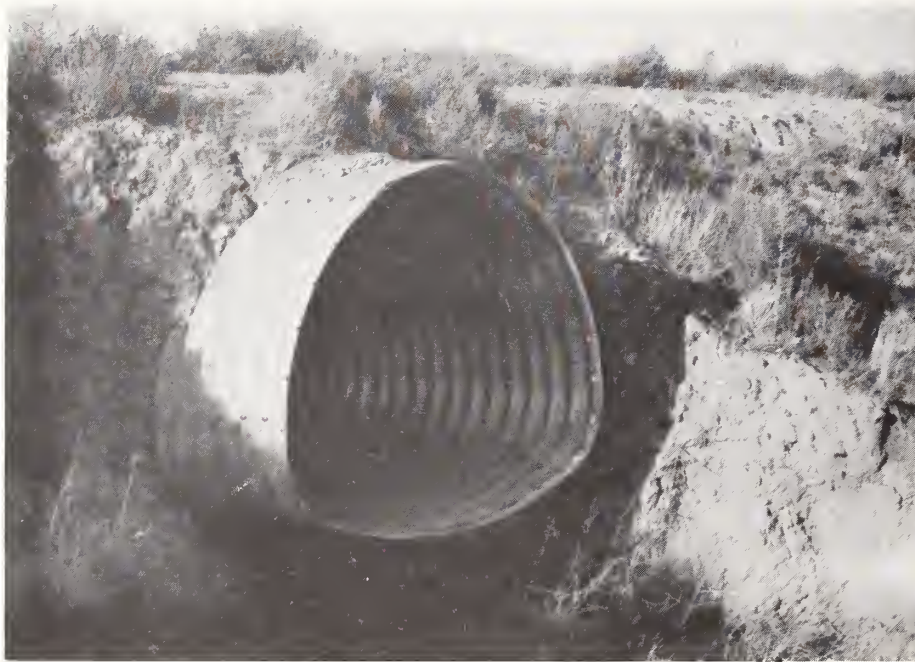
The Chester Culvert, which was installed on a county road, in a silty clay soil having a PI of 12, is shown in Figures 41 and 42, as it appeared in July of 1964. There was a large piping hole on each side of the inlet and several small piping holes were visible underneath the badly undermined outlet.

FIGURE 41. OUTLET OF THE CHESTER CULVERT IN JULY, 1964
Piping holes are under the outlet.

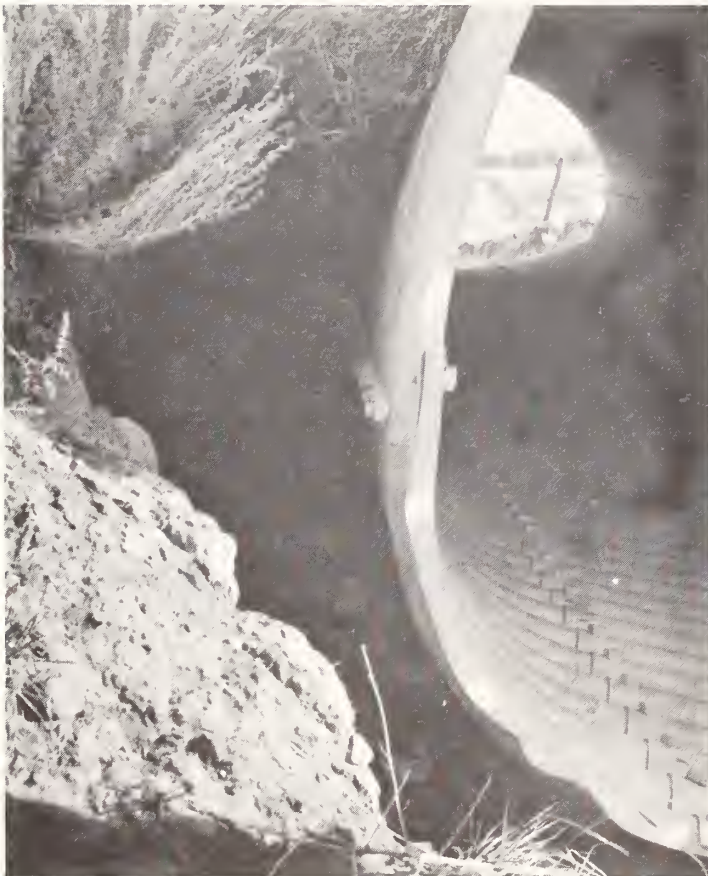
FIGURE 42. A LARGE PIPING HOLE
ON THE LEFT SIDE OF THE INLET
OF THE CHESTER CULVERT IN JULY,
1964.
